SITE ASSESSMENT REPORT

JENSEN DRIVE DRUM SITE
Houston, Harris County, Texas

November 10, 1988

SUBJECT: Site Assessment of Jensen Drive Drum Site
Houston, Harris County, Texas

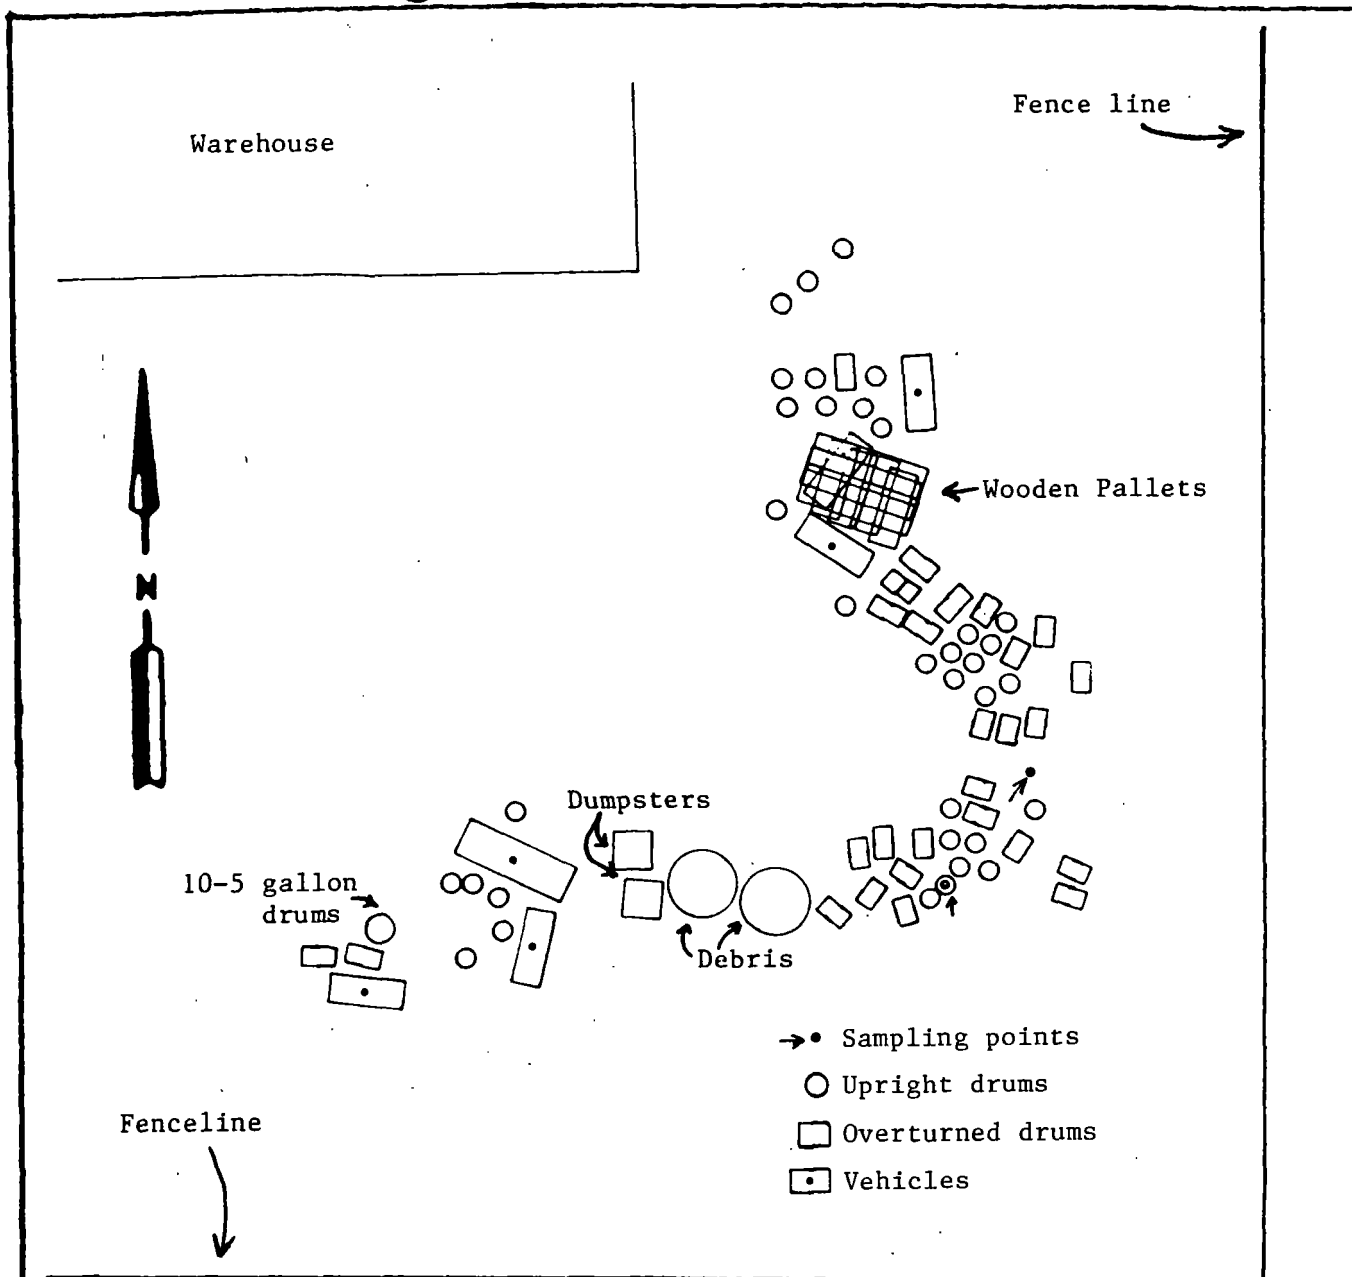
Figure 5

Location of drums and other objects at the Jensen Drive drum site (southeast corner).

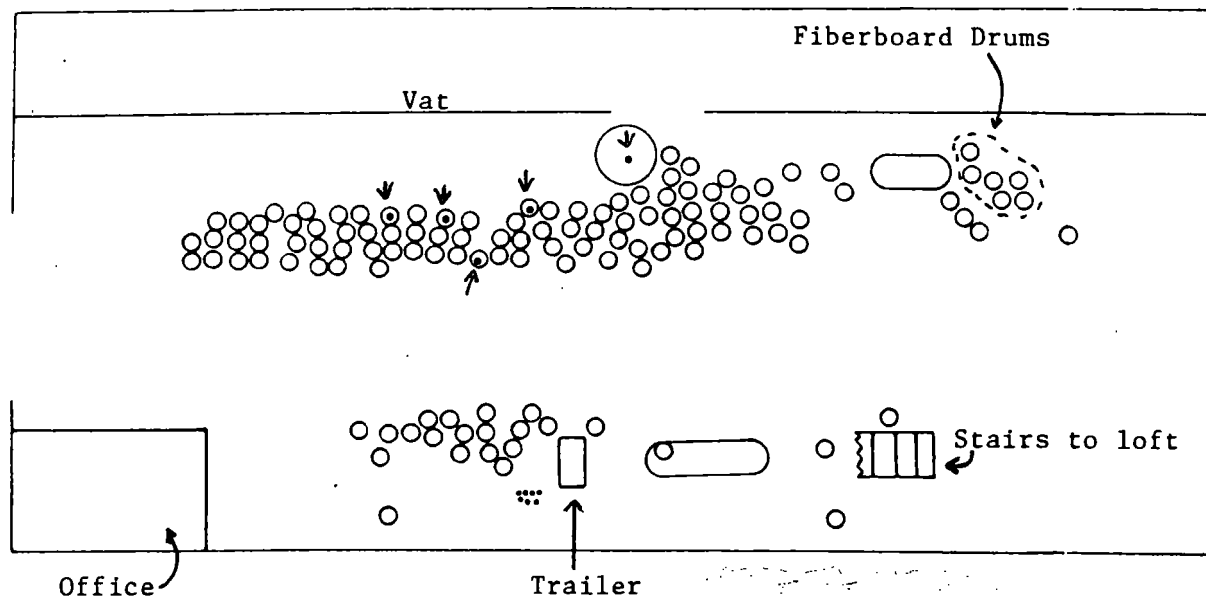
Figure 6

The warehouse contains 91 steel drums, 20 filterboard barrels, 10 compressed gas cylinders and a 500 gallon polypropylene vat that is about half full. There is a small locked office in the southwest corner of the warehouse. This office has 10 five gallon cans. There is a loft along the interior south side of the warehouse where lumber is stored.

Sketch of warehouse
at Jensen Drive drum site
